CONFIDENTIAL INSPECTION REPORT

SUMMARY REPORT

Client: SAMPLE REPORT
Realtor: Terri Realtor, Sample Realestate
Inspection Address: 123 Sample way, Sample, Florida 33914
Inspection Date: 9/5/2004 Start: 9:00 am End: 12:00 pm
Inspected by: Louis Korchick

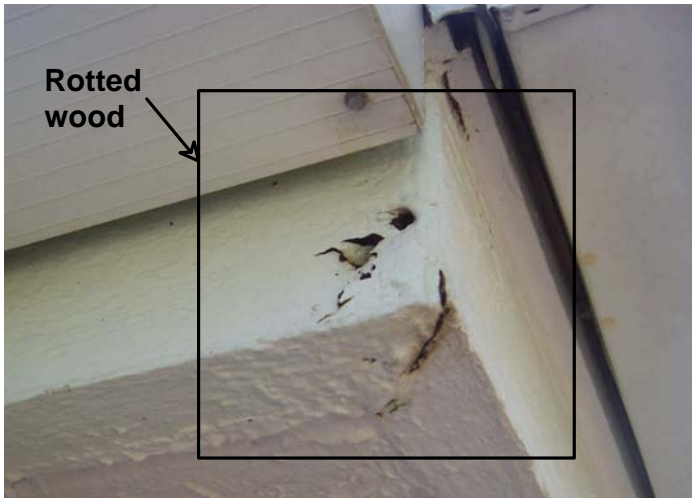
Fascia and Trim

- Sections of the fascia board or wood trim are rotted and have separated slightly, and should be serviced to prevent further deterioration.

Sections of the fascia board or wood trim are rotted and have separated slightly, and should be serviced to prevent further deterioration.

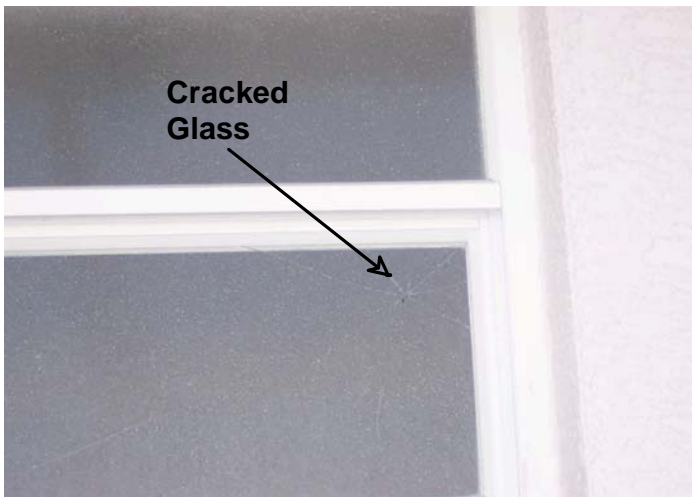
Windows

- There are broken window panes on the back window of the house which should be repaired.

There are broken window panes on the back window of the house which should be repaired.

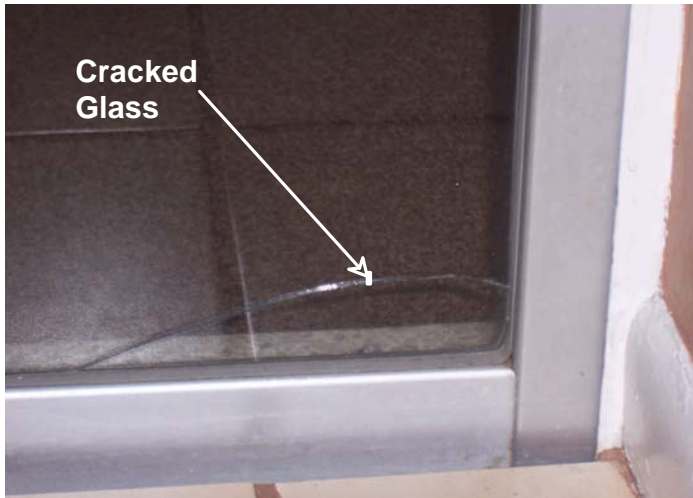
Sliding Glass Doors

- One of the glass panels in the slider is broken, and should be replaced with tempered glass.

One of the glass panels in the slider is broken, and should be replaced with tempered glass.

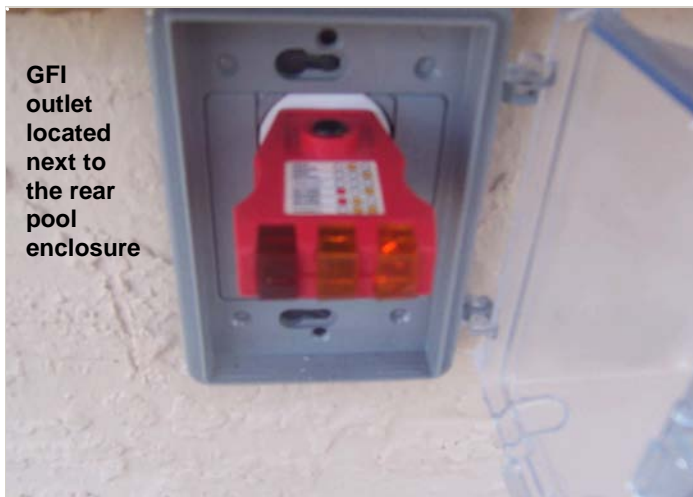
Outlets

- A ground-fault protected outlet in the rear does not trip on test, and should be serviced.

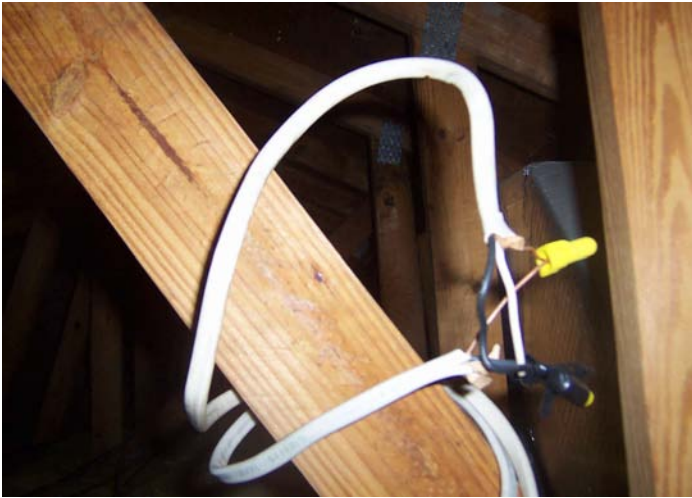
Attic

- An electrical connection within the attic has been incorrectly made outside of a junction box. Recommend having wires properly installed inside a junction box.

An electrical connection within the attic has been incorrectly made outside of a junction box. Recommend having wires properly installed inside a junction box.

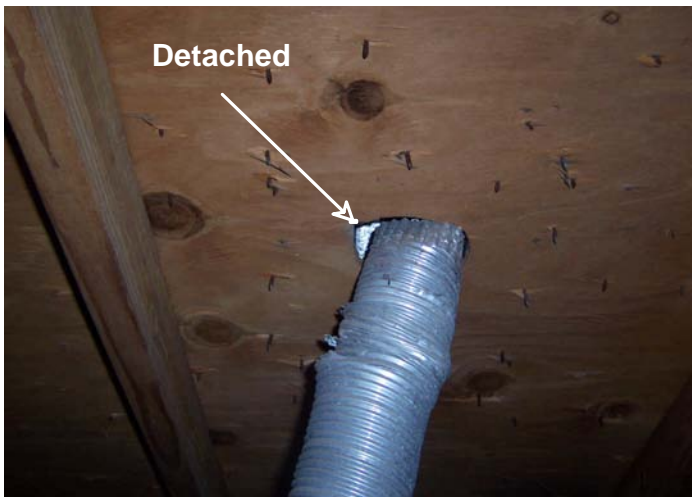
Exhaust Ducts

- A bathroom exhaust duct vents within the attic, and should be extended to an exterior port.

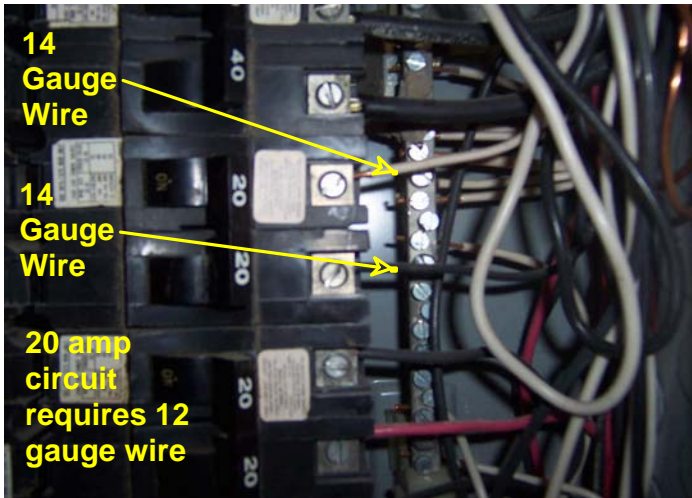
Main Panel

- Two breakers in the main panel are serving undersized wires and should be replaced with the proper size breaker.

Two breakers in the main panel are serving undersized wires and should be replaced with the proper size breaker.

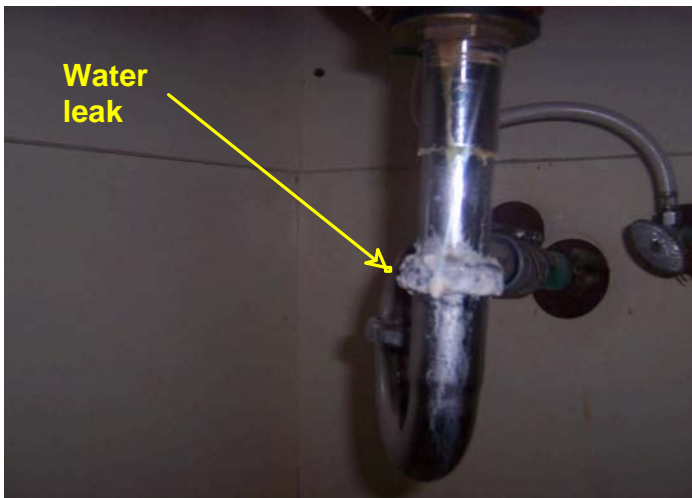
Master Bathroom

- There is a leak at the trap-arm below the dual bathroom sinks that should be repaired.
